Aluminium alloy failures in bathroom drainage

The following images are from one building site and are typical examples of the ~160 bathrooms. The supplier and original manufacturing companies have been wound up.

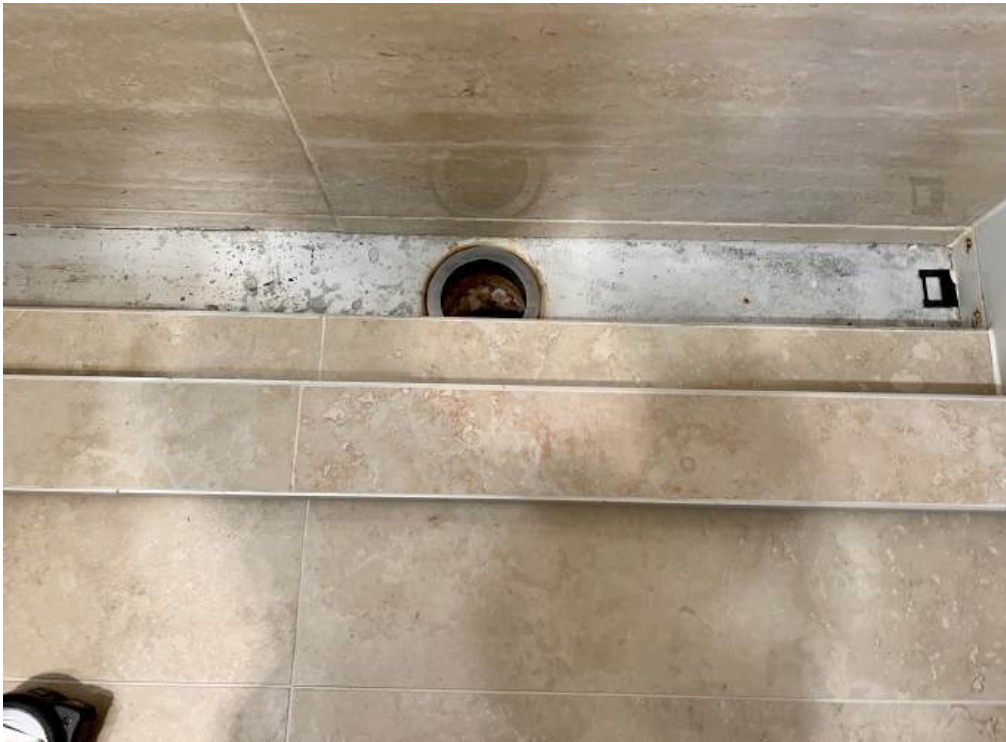
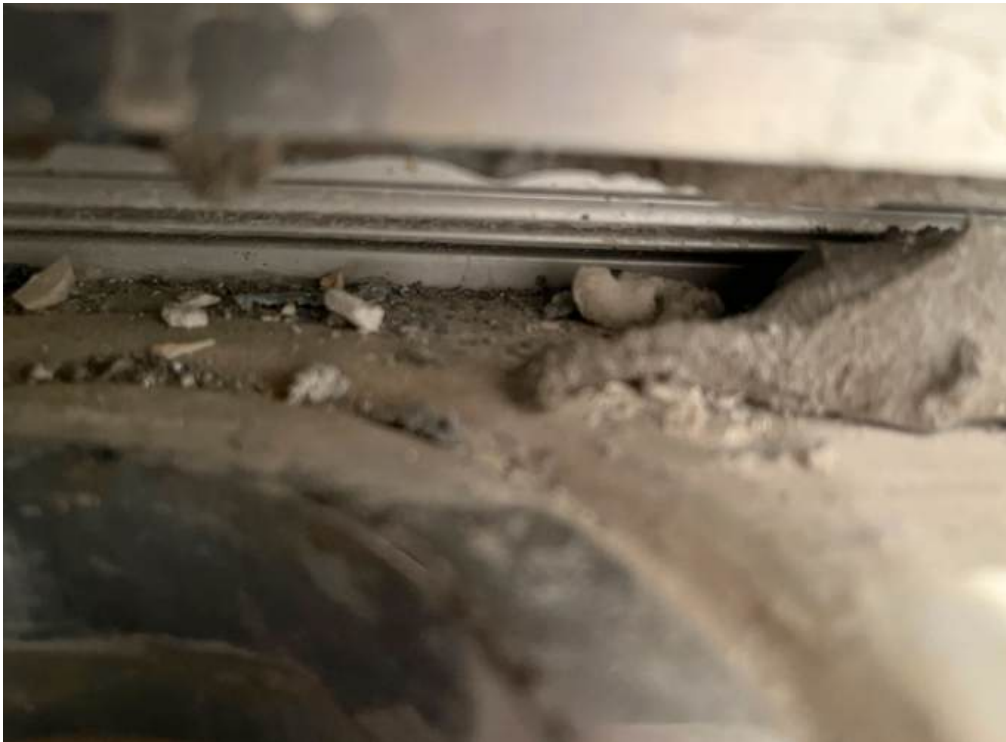
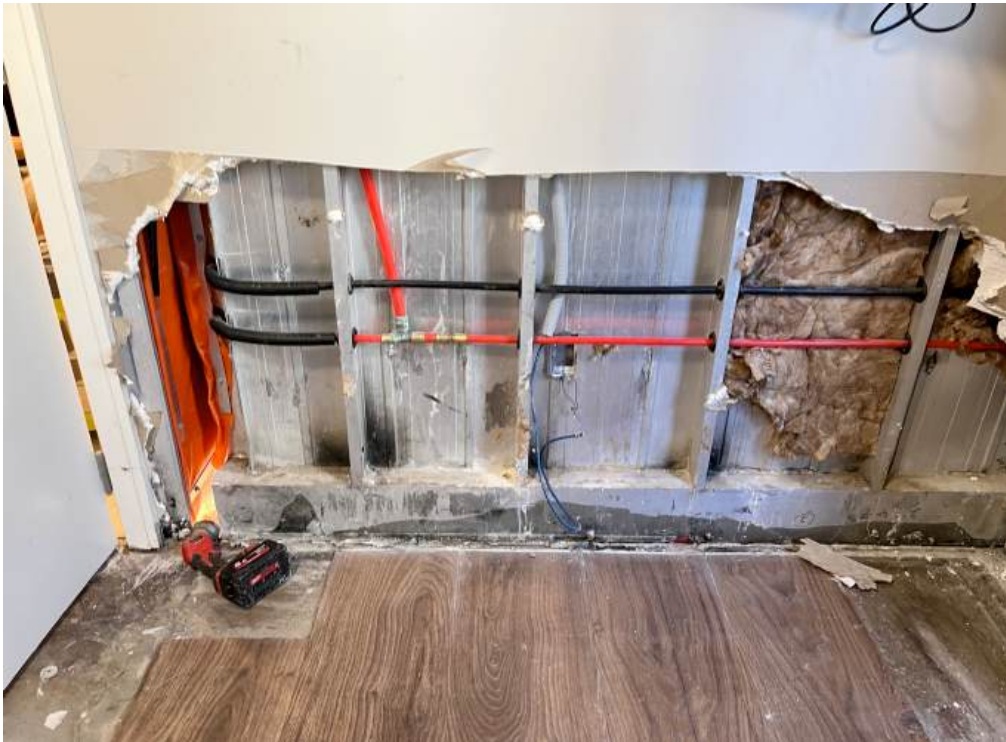
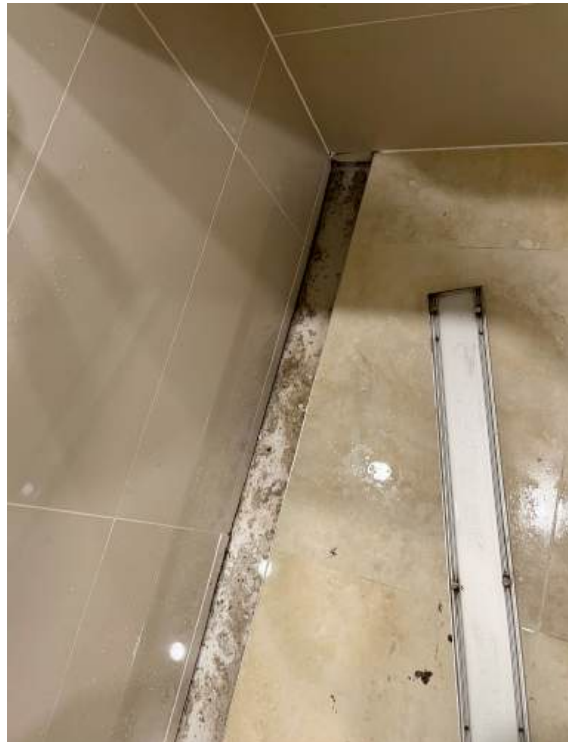
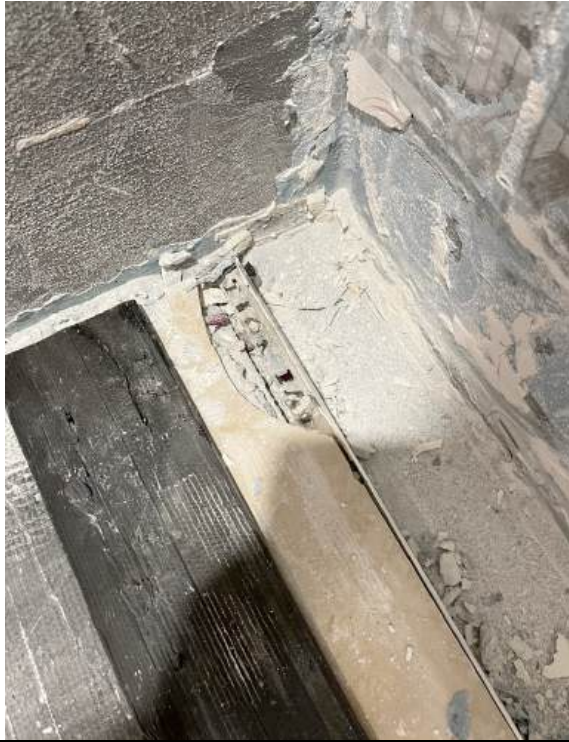
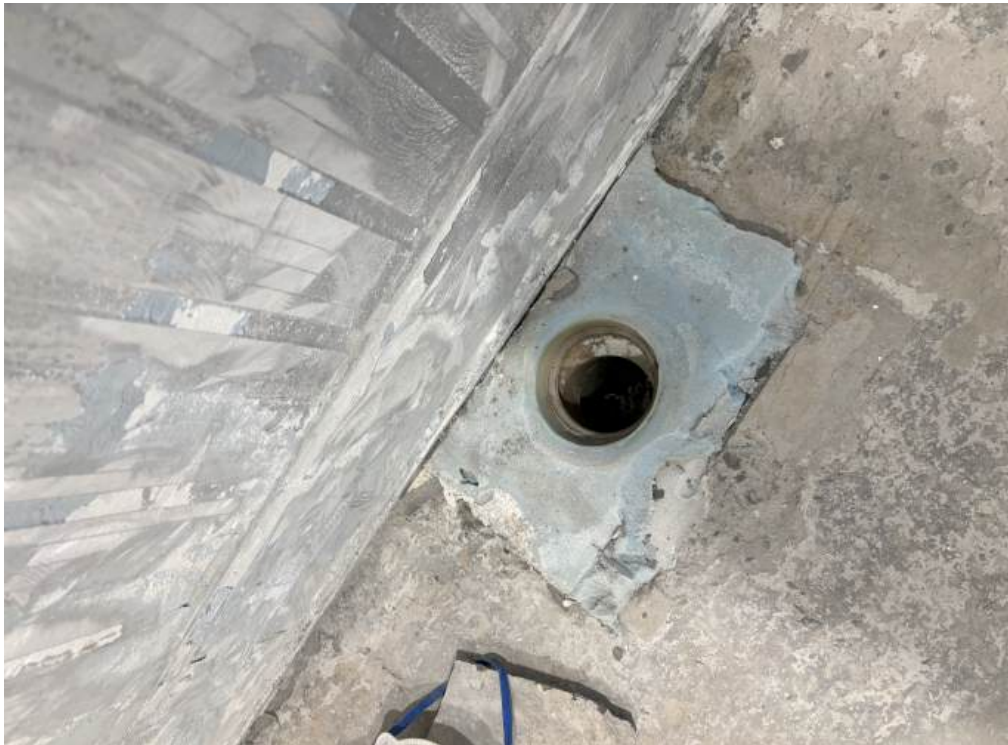
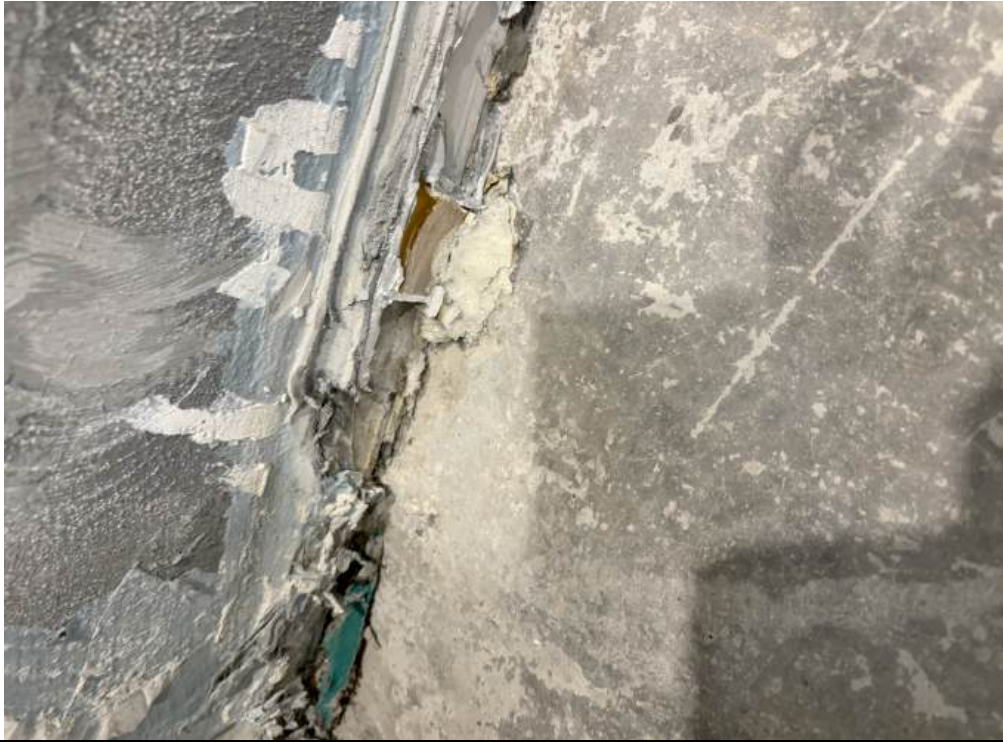
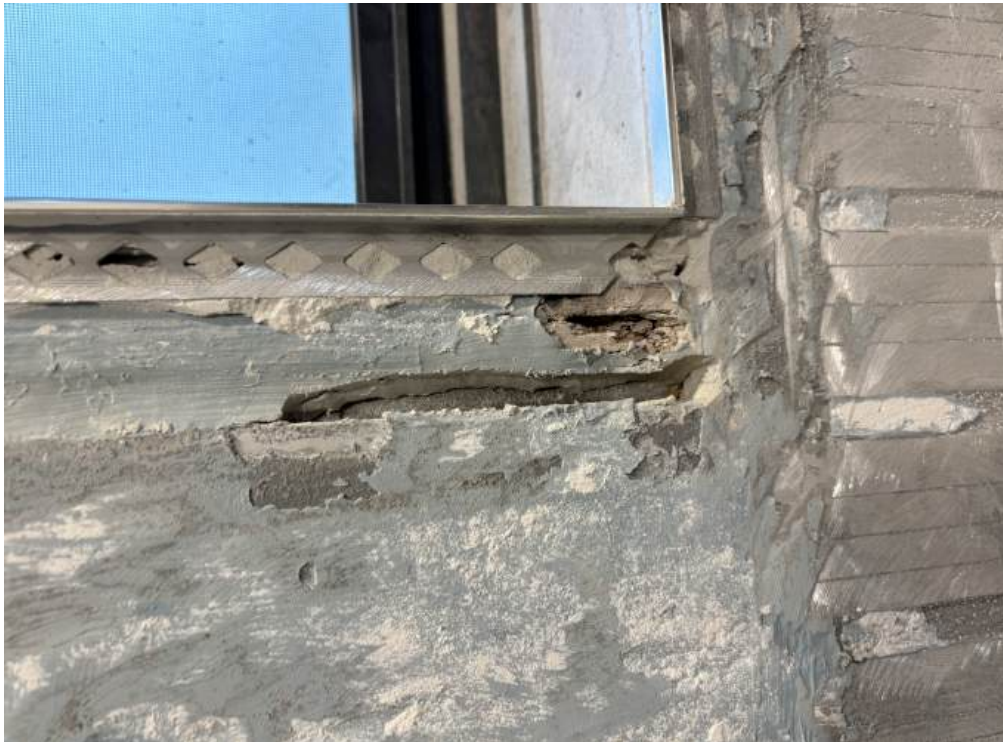
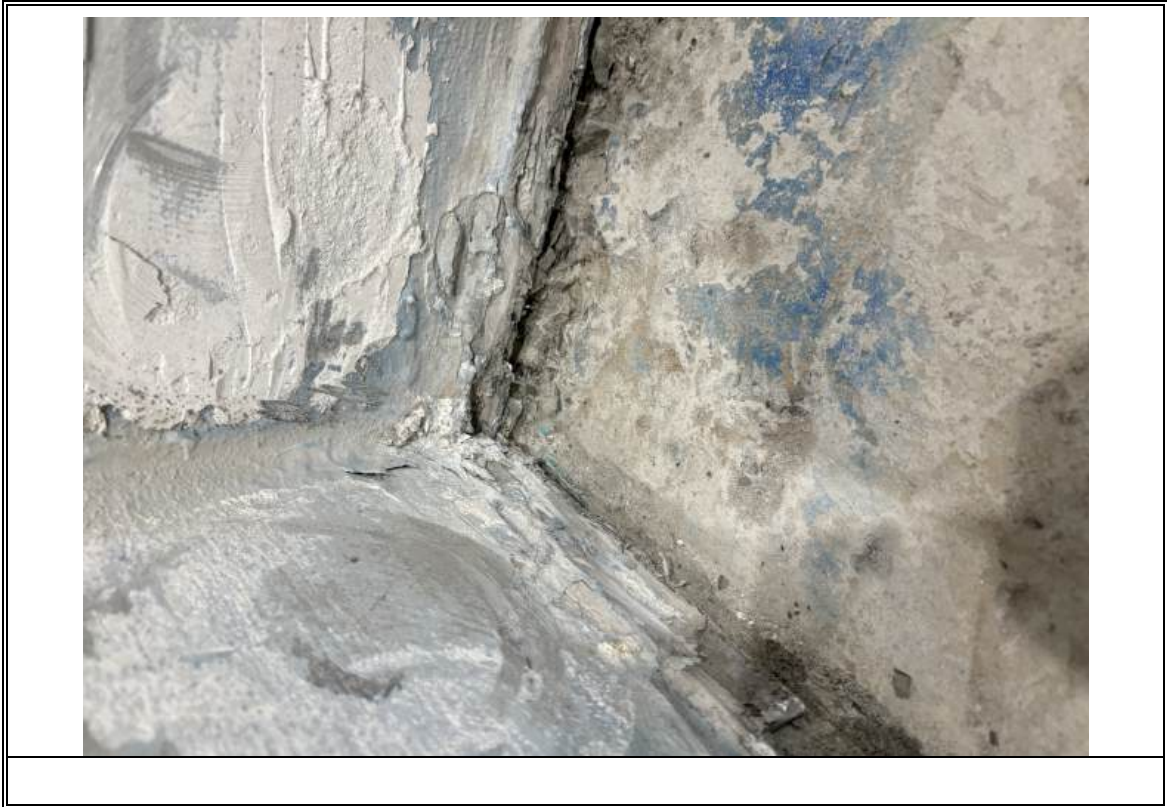
The failures began at the aluminium drainage channel. The drainage channel is formed from interlocking extrusions that also form the floor.

The waterproofing primer & membrane detached from the aluminium, and the tiles became 'drummy' and 'leaks' appeared as water was able to escape the bathroom.

There was primer and waterproofing over the aluminium surface forming the floor, however this also detached from the aluminium substrate in patches and sheets.

Essentially it seems the crevice corrosion has occurred as stated in the Joint Technical Bulletin from the Aluminium Council and the Australian Window Association, not only on the many crevices, but on the broader anodised surface as well.

The builder has currently 160 bathrooms being rectified and is replacing all the bathrooms and drains. His estimate of costs at present is about \$3.5 million. He currently wishes to remain anonymous, and also wishes the site address to be not released for owner and tenant privacy. Subject to suitable confidentiality, an inspection could be arranged.
