PRELIMINARY IMPACT ANALYSIS

This proposal seeks to review Joint Australian New Zealand Standard (AS/NZS) 3500, *Plumbing and drainage Part 2: Sanitary plumbing and drainage* to amend the requirements for connecting of drains installed at grade.

Responsible Technical committee: Australian Standard Committee WS-014, *Plumbing and Drainage*

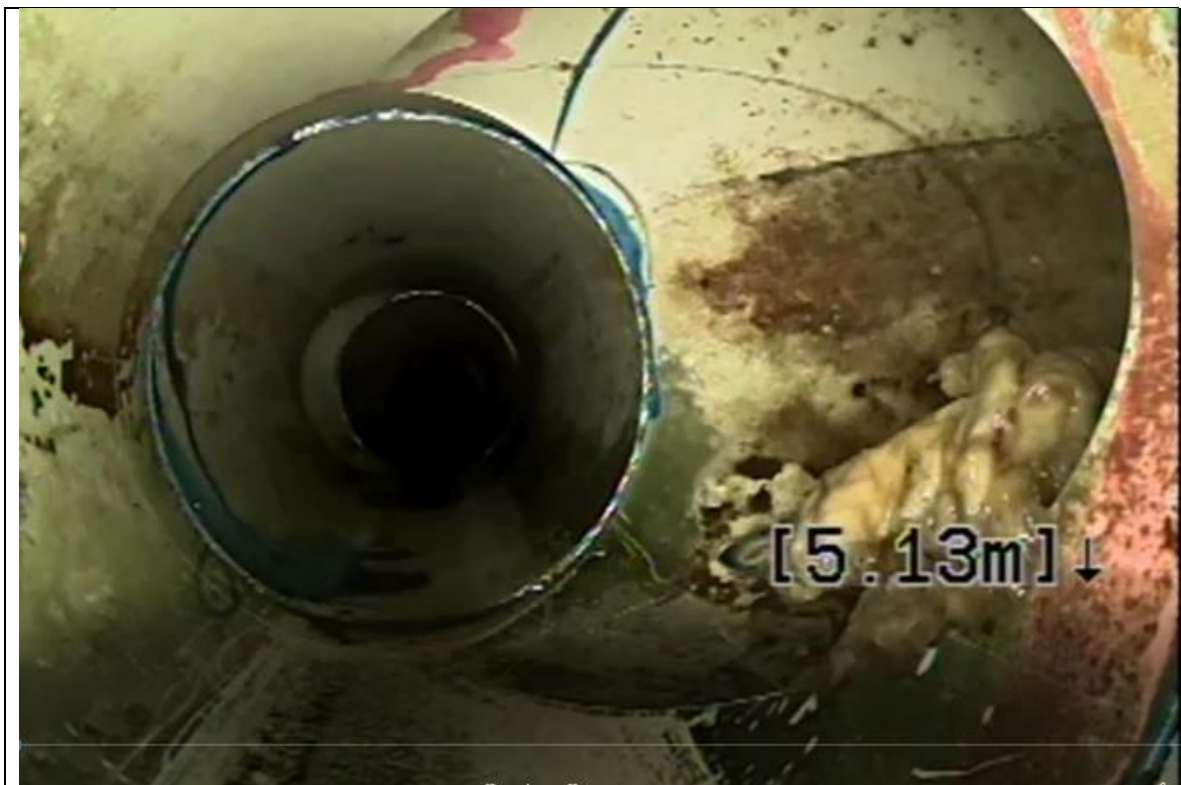
However, a leading plumbing practitioner has experienced blockages in a drainage networks using 45degree junctions in a high profile commercial building where in one a month period 14 blockages were reported that required clearing. A CTV image building below shows a blockage at the junction.

This image shows waste stranding in the branch of a 45 degree junction.

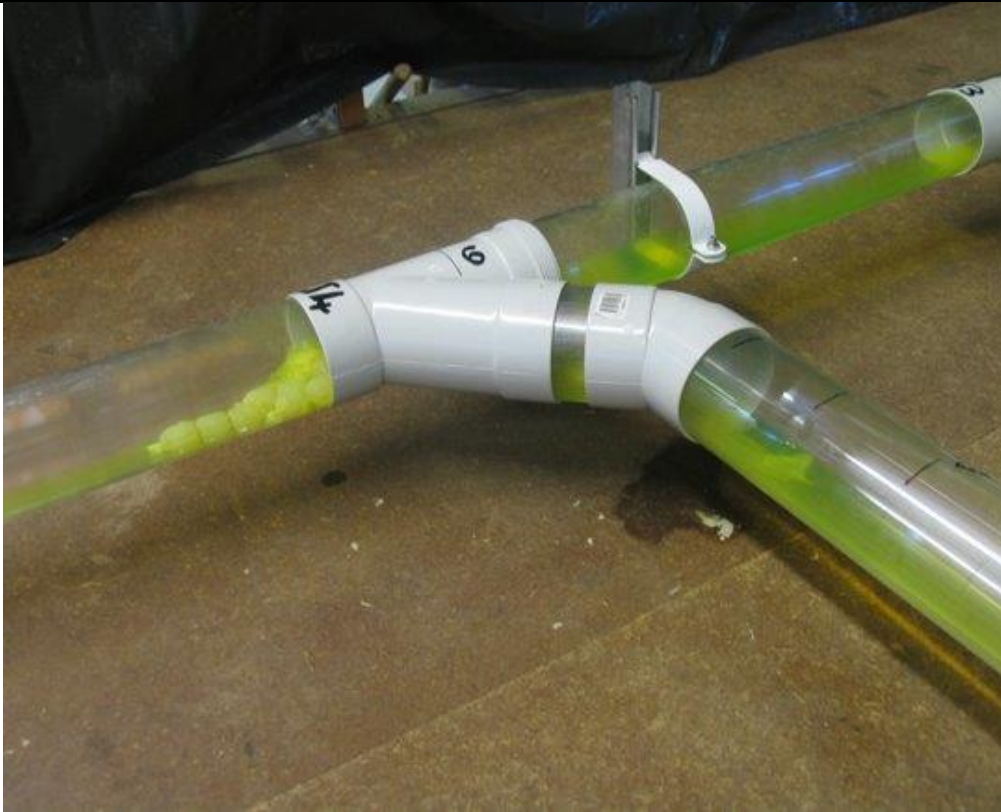
The test methodology used for the above rig configurations involved the testing of a 4.5/3L toilet as in the Western Australian installation followed applicable AS1172.1&2 test procedures. For comparison purposes other flush volumes were also tested. The test media was combined to replicate actual usage conditions for each test as follows:

- Four artificial test media solids made to the Australian Standard AS1172.1-2005 Appendix C and four crumble balls consisting of 7 adjoining sheets of single ply tissue toilet paper
- Four artificial test media solids made to the UNAR Guidelines and Specifications -2006 for Toilet fixtures and four crumble balls consisting of 7 adjoining sheets of single ply tissue toilet paper
- Four crumble balls consisting of 7 adjoining sheets of single ply tissue toilet paper

The image above shows the waste blockage/stranding at the 45 degree junction and up into the branch line in the standard test configuration

Test results showed the 4.5L full flush discharge from the toilets performance was adversely affected by each 45-degree junction. During a full flush discharge, the water was found to travel up each of the four branch lines significantly reducing the flush volume carrying the waste test media, stranding the solids and paper. Standing was also observed within the 45-degree junction caused by the redirection of the flow of the waste from the junction, refer to the link and images below.

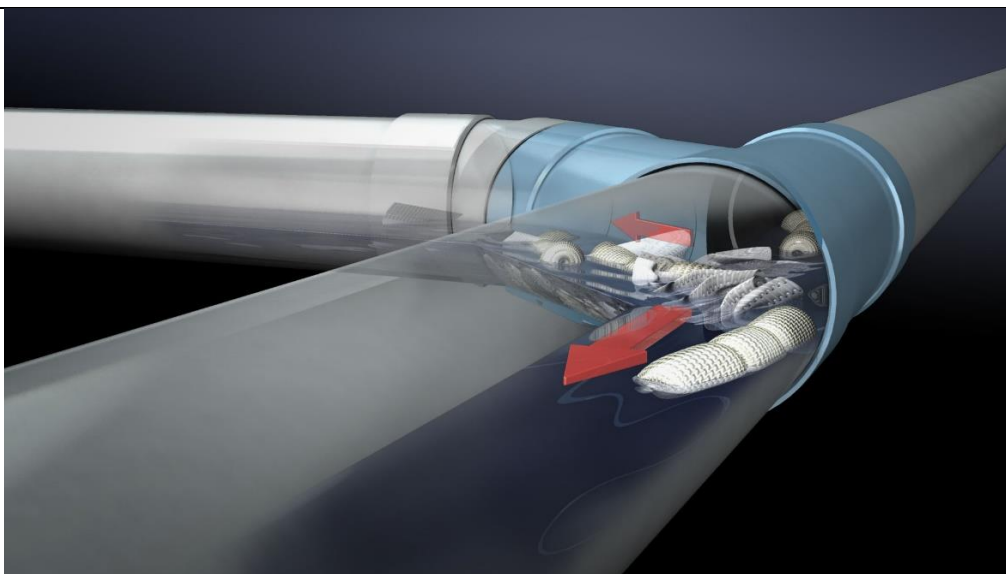
The graphic image above shows the redirection of the flush discharge and waste as it travels down the drain line and into the 45 degree junction connection area

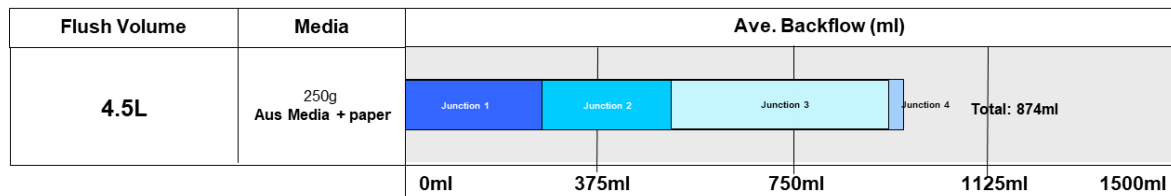
Testing showed that the wastewater flowed through each of the 45-degree junctions into the branch lines. Results were measured from each junction and the water loss totalled 874 ml or a 19% loss of the original 4.5L full flush volume discharged from the Water Closet.

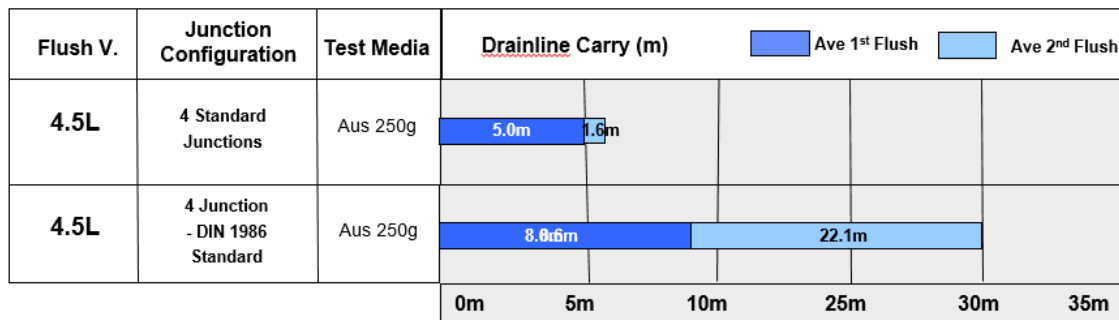
The average sanitary drainage transportation distance of solid and paper test media achieved was 5 metres after a single flush and 6 metres after two flush discharges (see below results).

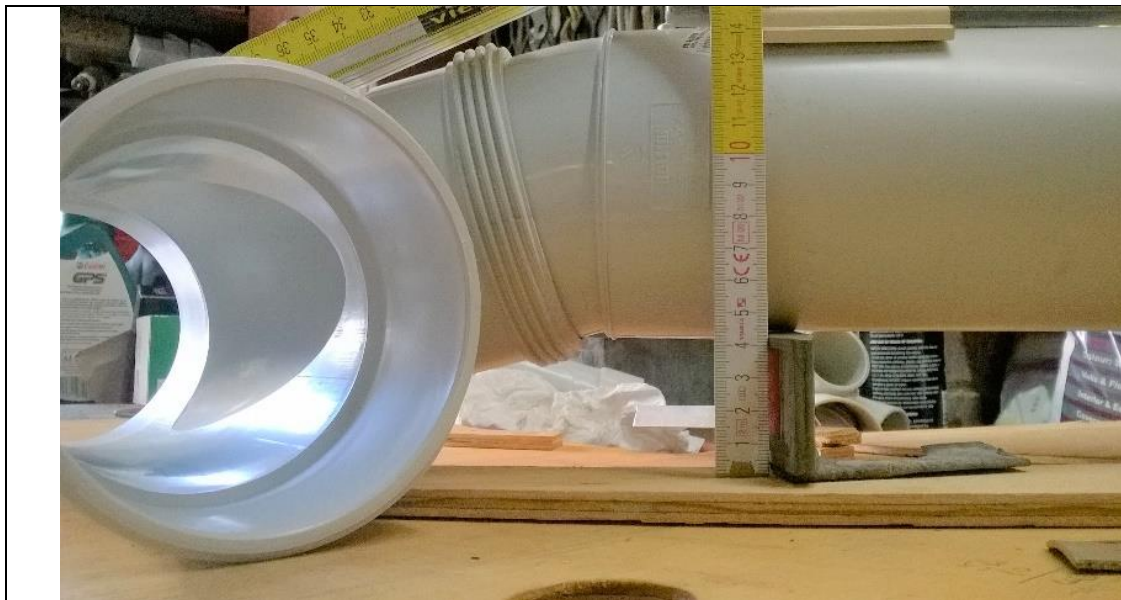
To further investigate the implications of this proposed change, Standards Australia's WS-14 committee conducted a study to determine the increase in height associated with inclining the junction 15 degrees. This height increase was measured to be 43mm (see image below).

This image shows the approximate increase in pipework height is 43mm resulting from an increase in inclination of the junction by 15 degrees.

As a result of the change to the entry angle there will be a slight increase of required space, around 45mm. There has been some concern expressed that there may not be sufficient space available for additions to existing sanitary drainage systems. This would make it difficult to comply with the new requirements. For this reason it is proposed that the 15° angle only be a requirement for new sanitary plumbing and drainage systems. For repairs or additions to existing systems use of the 15° angle will only be a recommendation. When responding to this request for information, it would be appreciated if you could address the following points:
